U. S CIVIL AERONAUTICS BOARD
AIRCRAFT ACCIDENT REPORT

UNITED AIR LINES, INC , DC-8, N 8013U, AND
TRANS WORLD AIRLINES, INC., CONSTELLATION 1049A, N 6907C,
NEAR STATEN ISLAND, NEW YORK, DECEMBER 16, 1960

SYNOPSIS

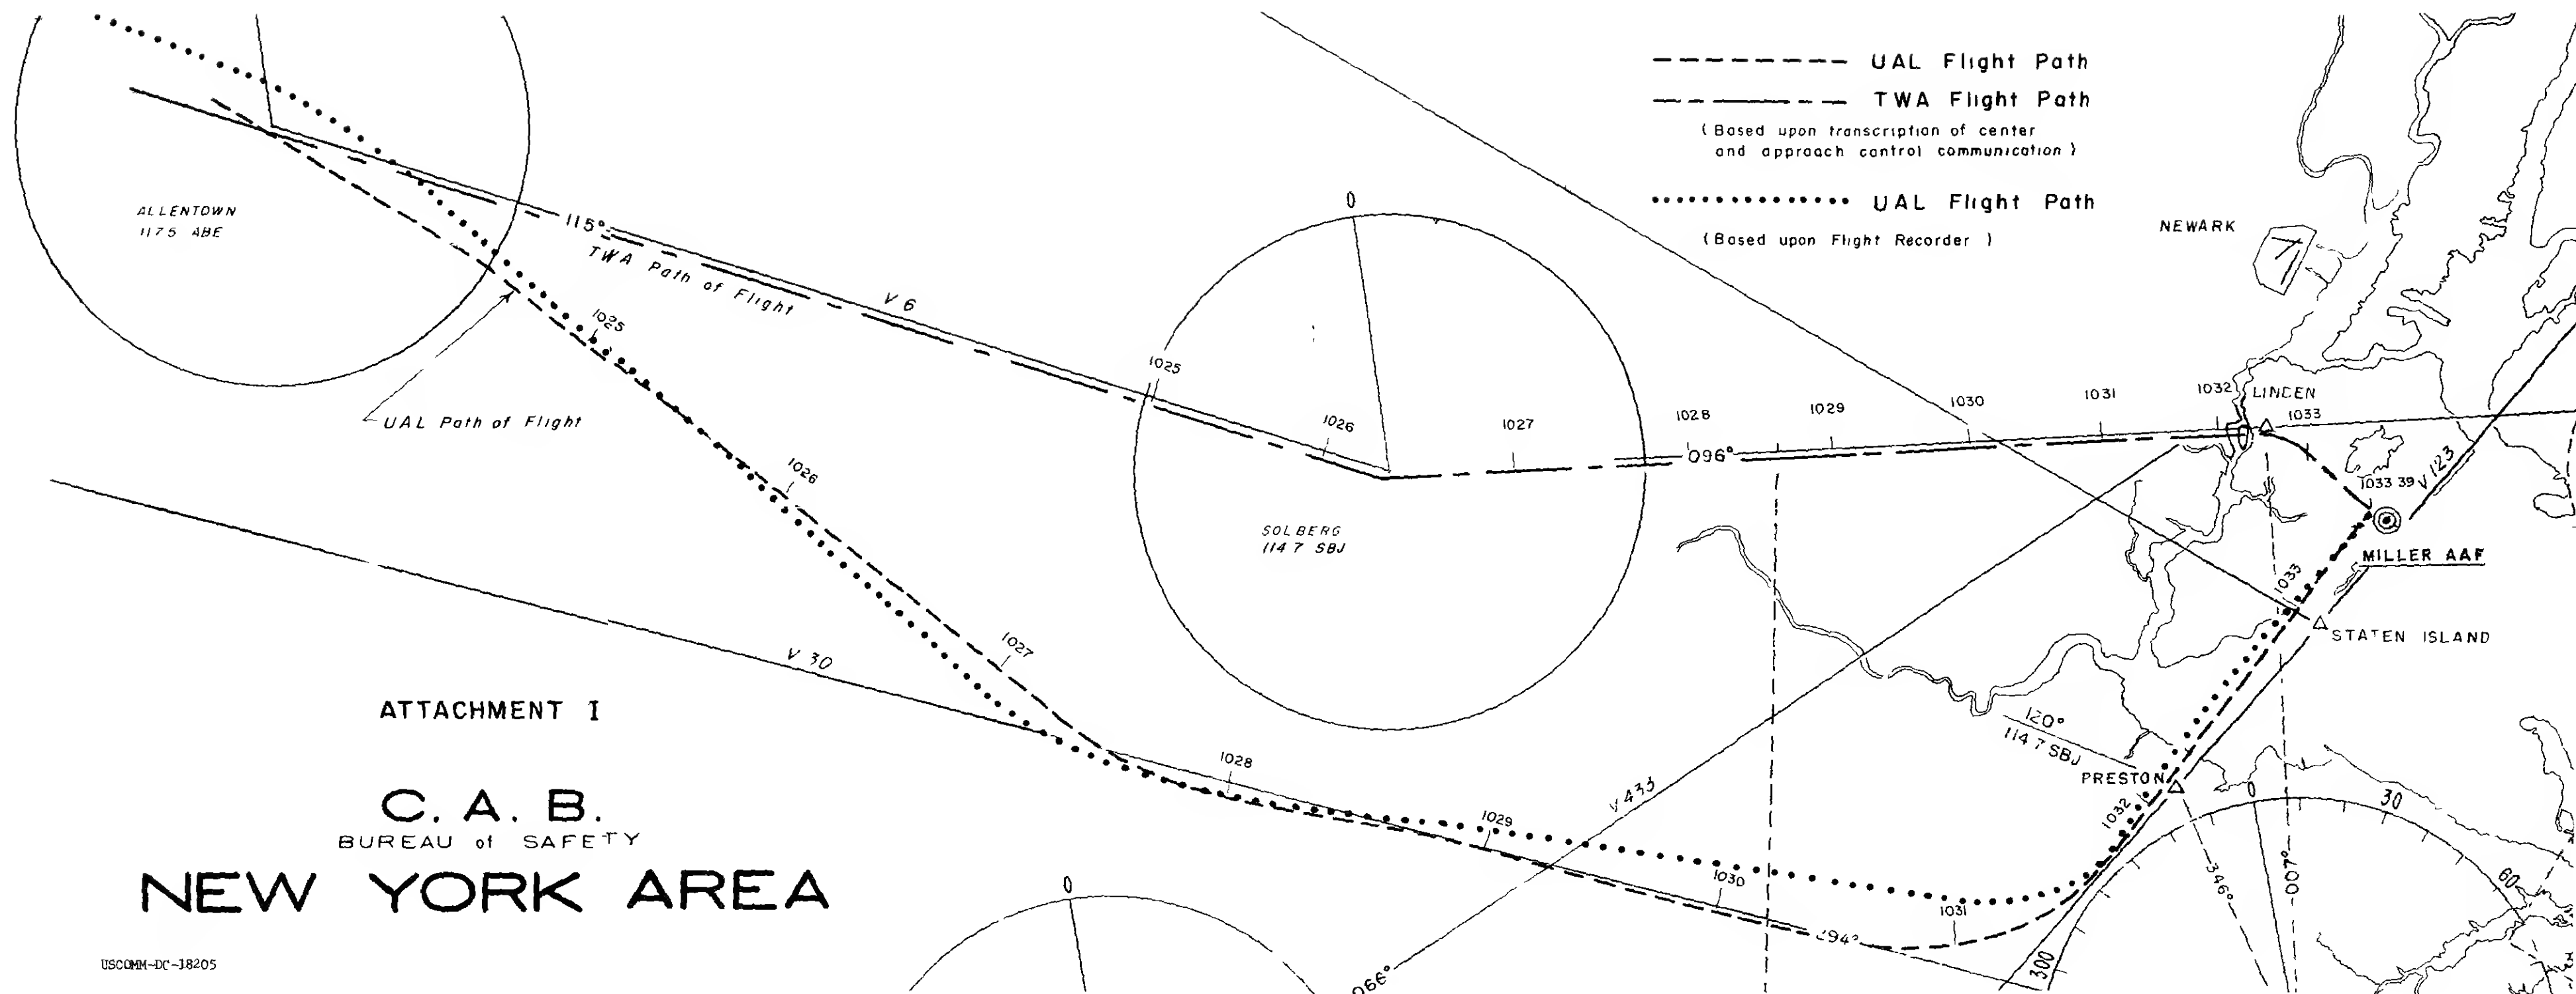
ATTACHMENT I

C. A. B.
BUREAU of SAFETY

NEW YORK AREA

History of TWA Flight (See Attachment I as reference)
